STONY BROOK DAM
NO. 3

NJ 00389

PHASE 1 INSPECTION REPORT

NATIONAL DAM SAFETY PROGRAM

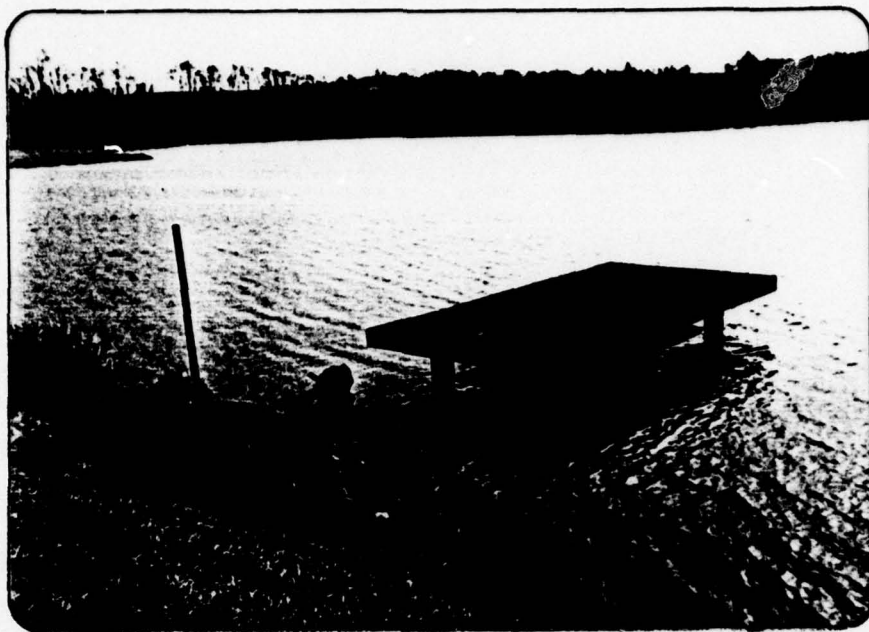
| VISUAL EXAMINATION OF | OBSERVATIONS | REMARKS OR RECOMMENDATIONS |
|--|--|---|
| INTAKE STRUCTURE | Concrete in new condition. No deterioration noted. Wheel for gate steam missing. | See photo |

View of intake structure

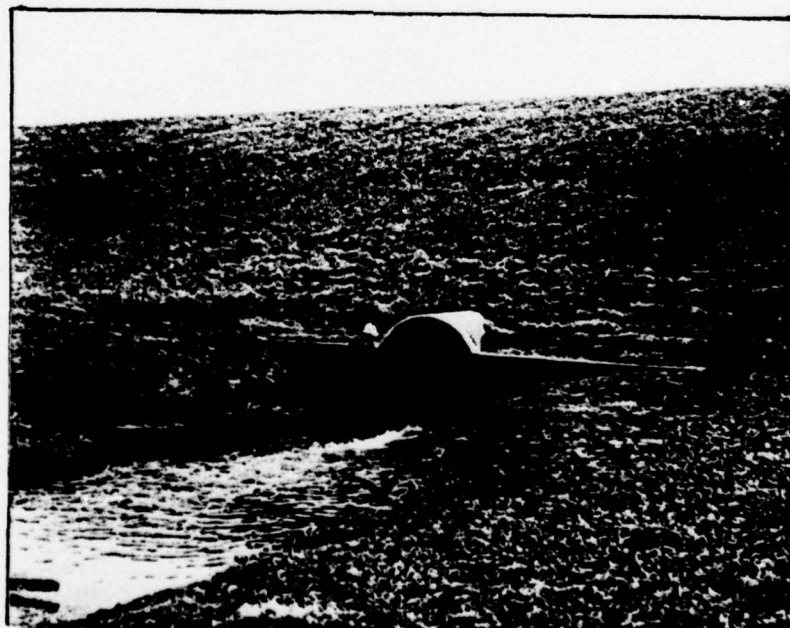
| VISUAL EXAMINATION OF | OBSERVATIONS | REMARKS OR RECOMMENDATIONS |
|--|--|---|
| OUTLET STRUCTURE | No deterioration noted. | See photo |

View of outlet structure

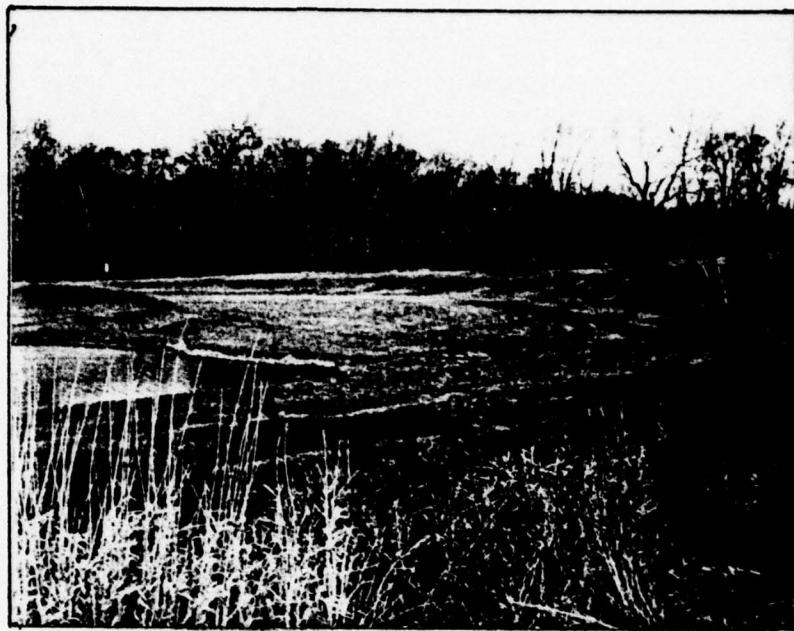
View of auxiliary spillway

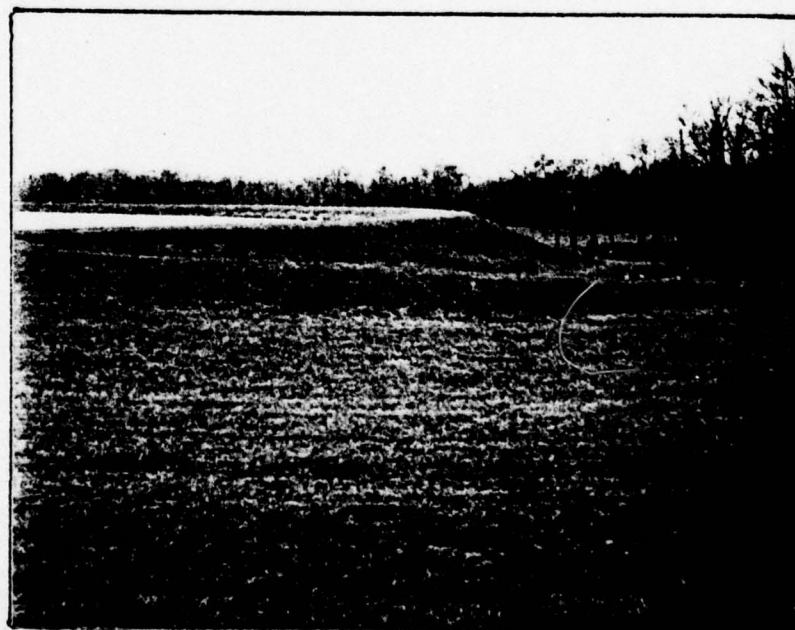
View of auxiliary spillway

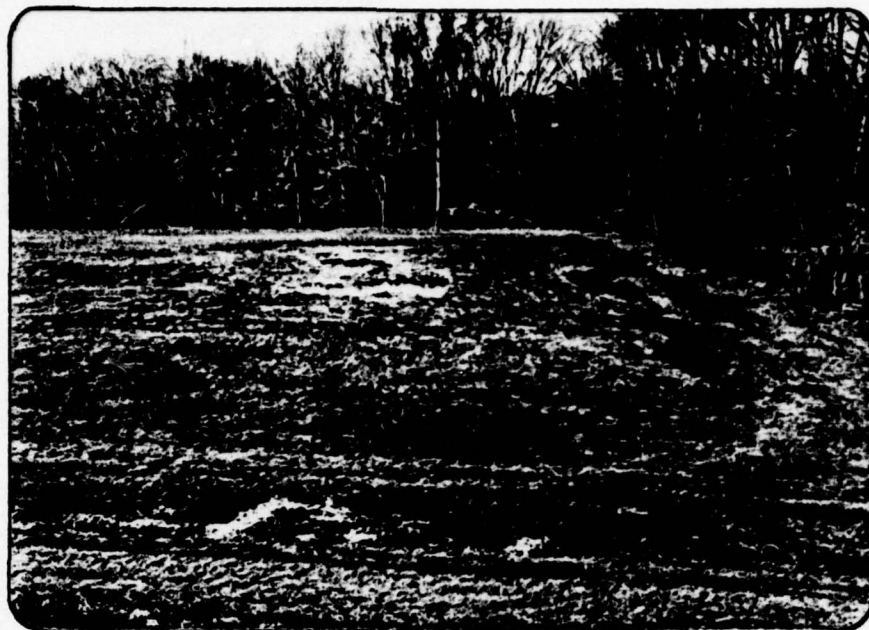
Seepage at toe

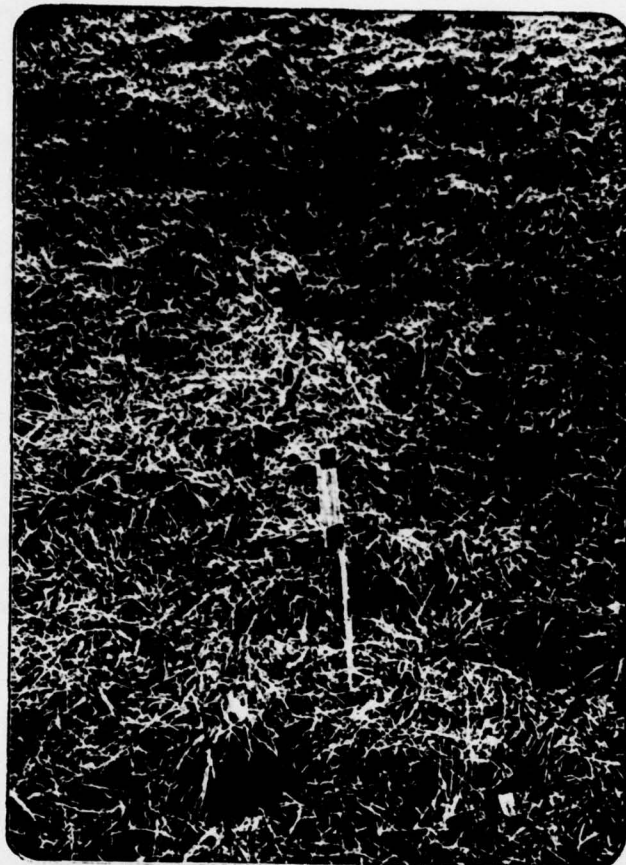
| VISUAL EXAMINATION OF | OBSERVATIONS | REMARKS OR RECOMMENDATIONS |
|--|---|--|
| SURFACE CRACKS | Shallow vertical cracks on right embankment. | Cracks appear to be the result of frost action and surface erosion rather than a structural deficiency. (See photo). |

Vertical surface cracks

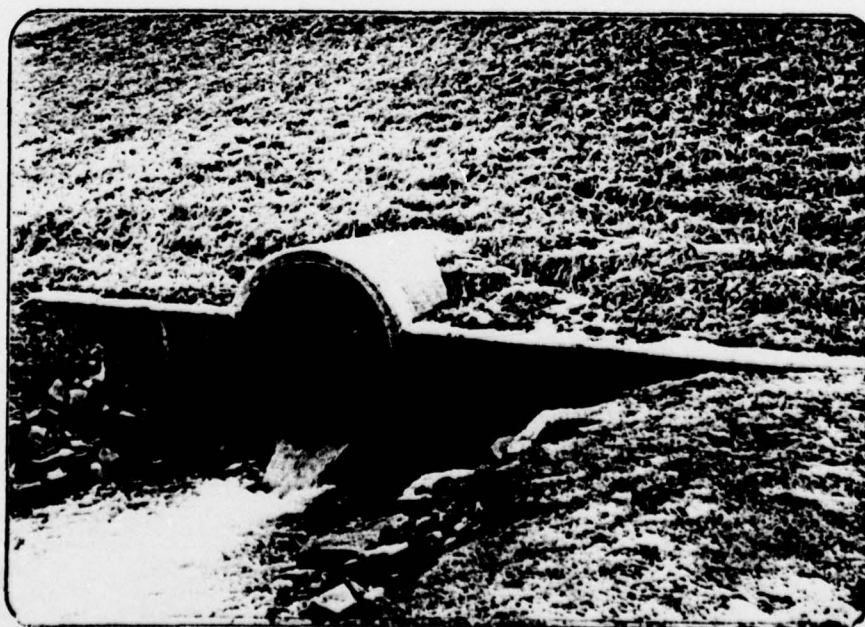
2-6" ϕ toe drains - one on each side of the outlet pipe in good condition.

Toe drains and seepage at outlet structure
